CITY OF BOSTON
BOSTON, MASSACHUSETTS

REPORT
OF
INVESTIGATION OF COLLAPSE
AT
HOTEL VENDOME

AUGUST, 1972

SUBJECT: Investigation of Collapse
at Hotel Vendome

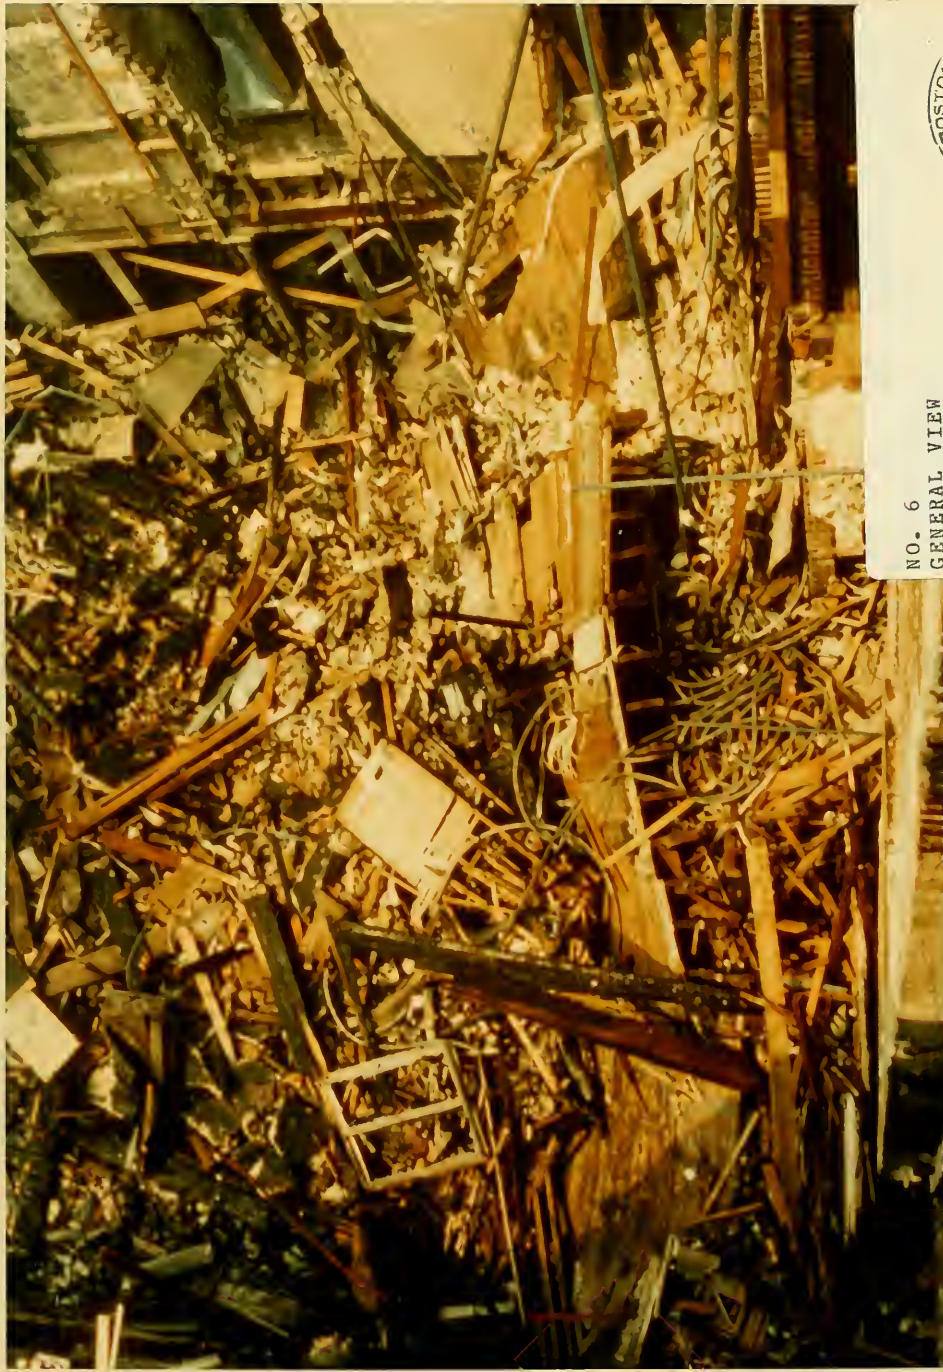
NO. 6
GENERAL VIEW
LOOKING DOWN AT DEBRIS
BEFORE START OF REMOVAL.

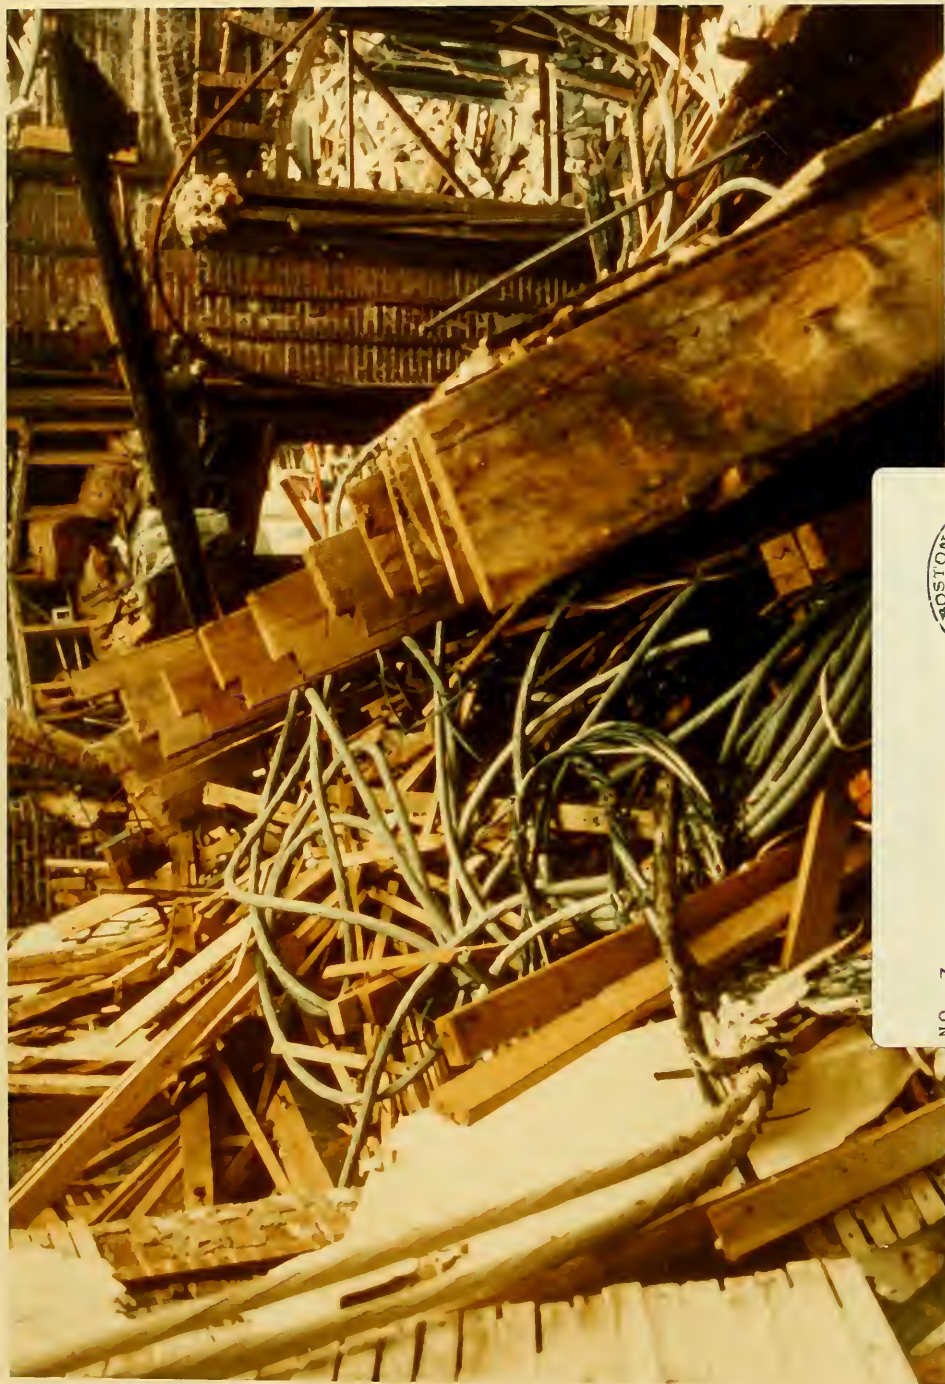
NO. 7
LOOKING EAST AT 5TH FLOOR
IN COLLAPSED POSITION

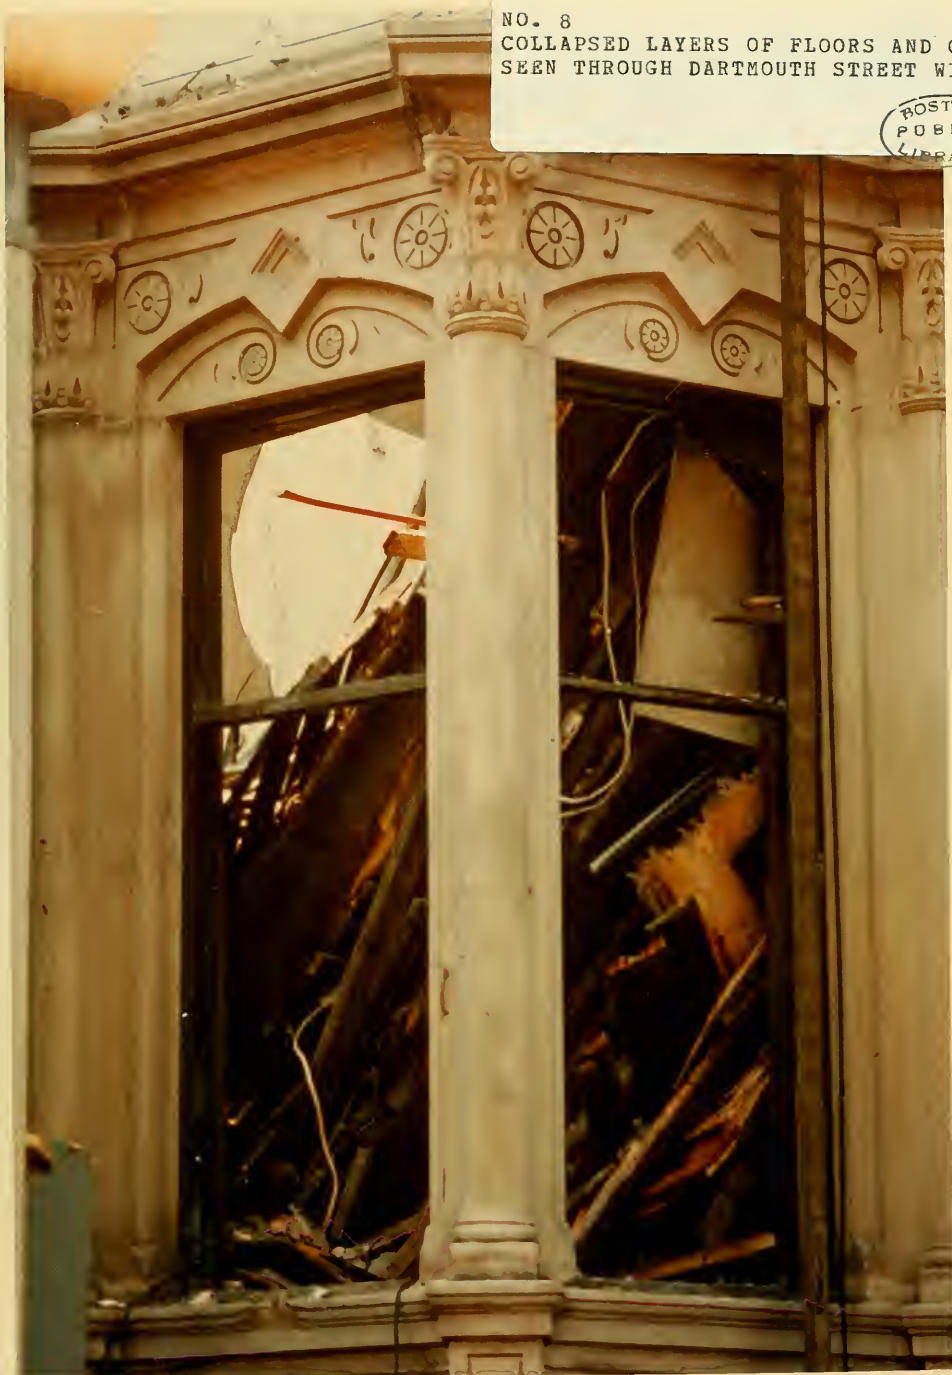
NO. 8

COLLAPSED LAYERS OF FLOORS AND CEILINGS
SEEN THROUGH DARTMOUTH STREET WINDOWS

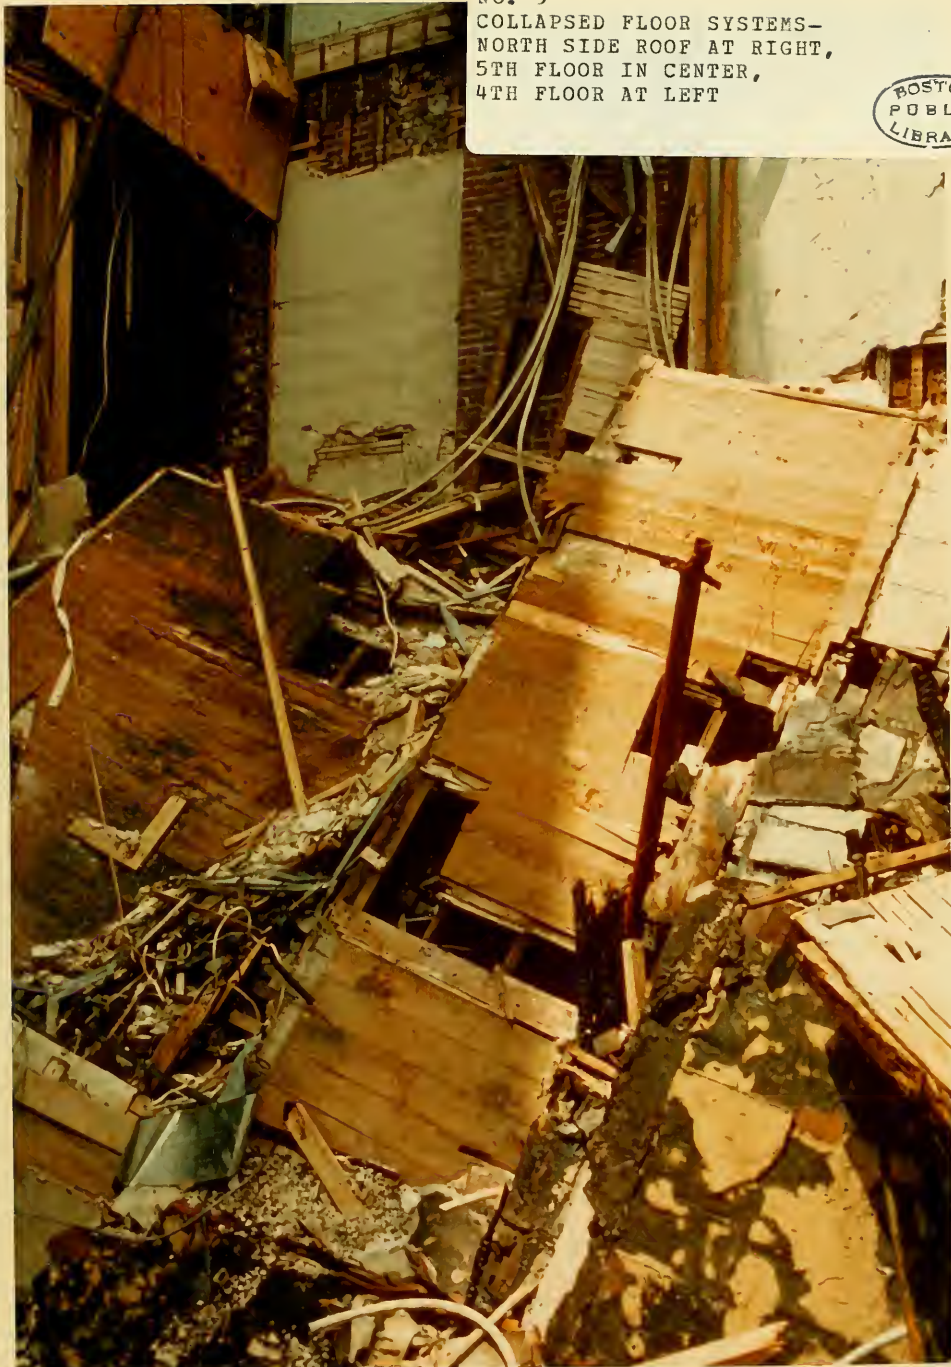
NO. 9

COLLAPSED FLOOR SYSTEMS—
NORTH SIDE ROOF AT RIGHT,
5TH FLOOR IN CENTER,
4TH FLOOR AT LEFT

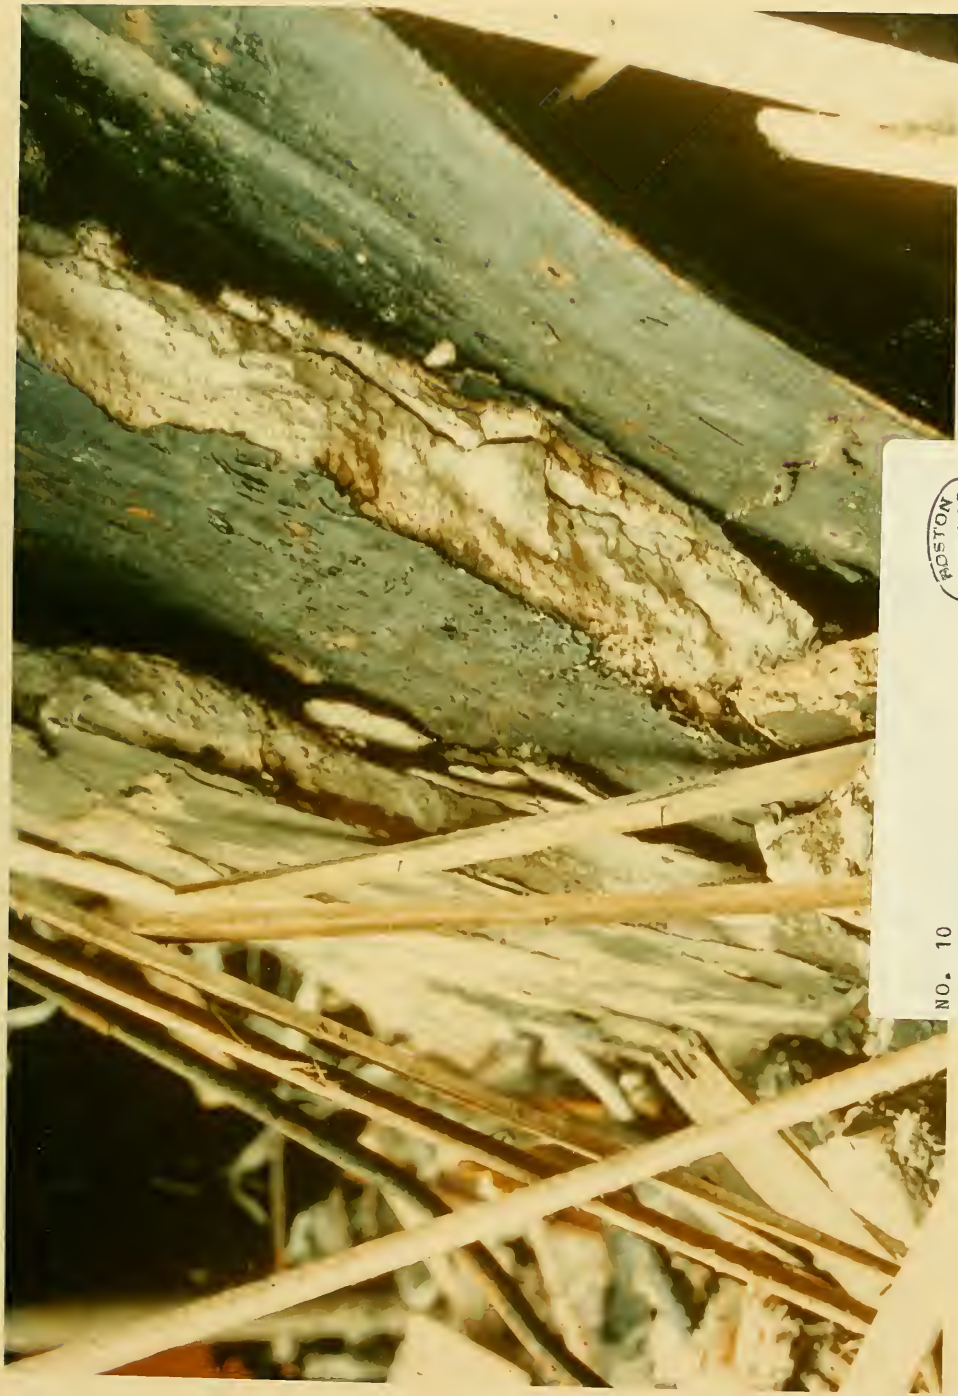
NO. 10

VIEW SHOWING

LAYERS OF ROOF CONSTRUCTION

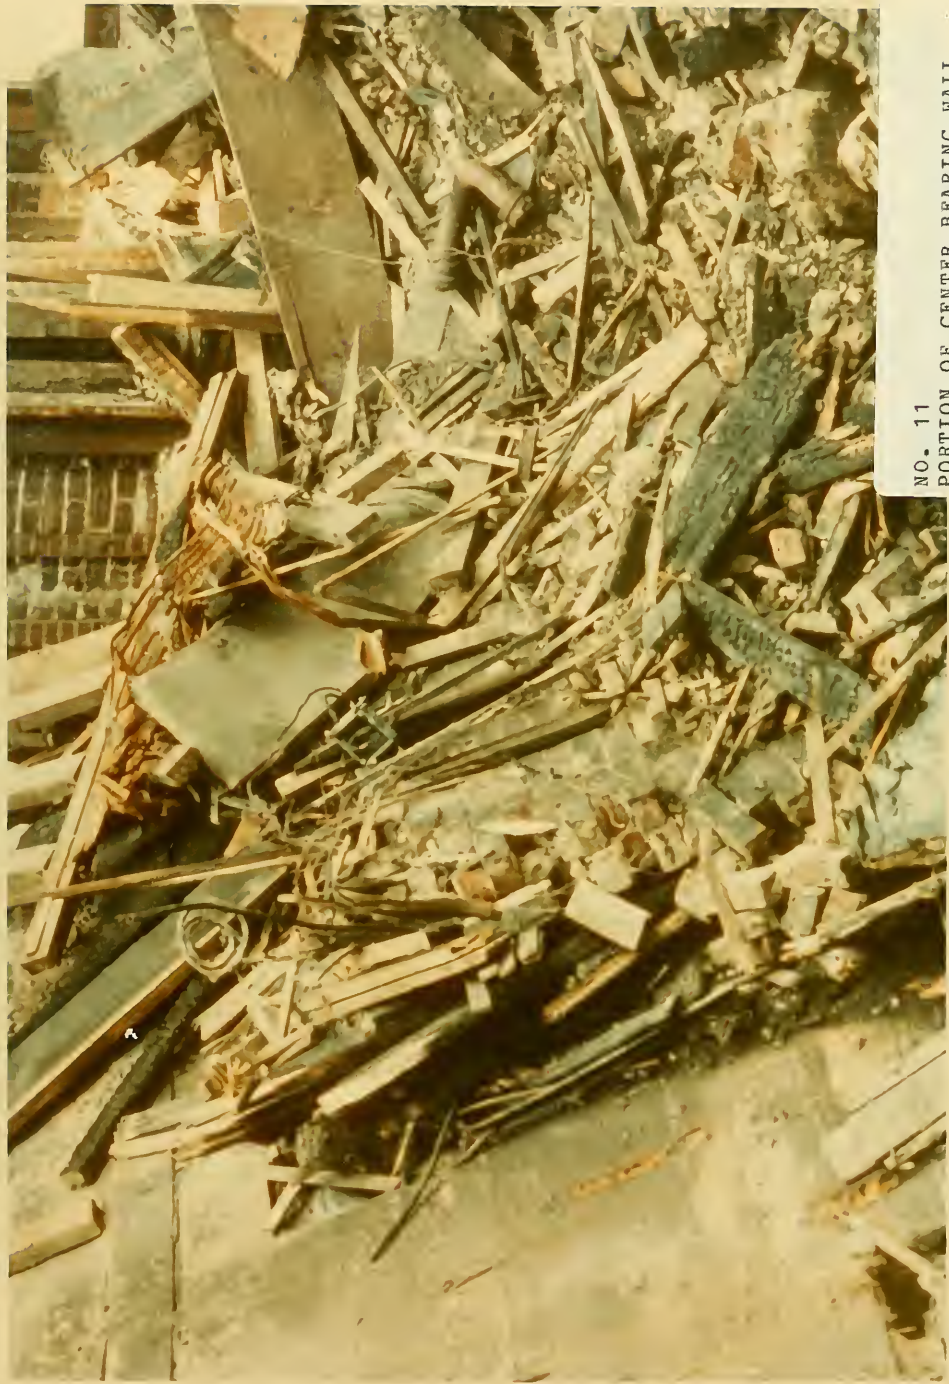
NO. 11

When the North section of the fifth floor was almost completely exposed, during removal of the debris, a portion of the central bearing wall was found laying against it. The bricks and mortar in this portion were intact and there were vertical furring strips on each side. Charred surfaces on each side indicated that this portion originally was located between fifth floor and roof.

PORTION OF CENTER BEARING WALL
LAYING AGAINST 5TH FLOOR—
APPROXIMATELY FOUR STORIES
BELOW ORIGINAL POSITION.

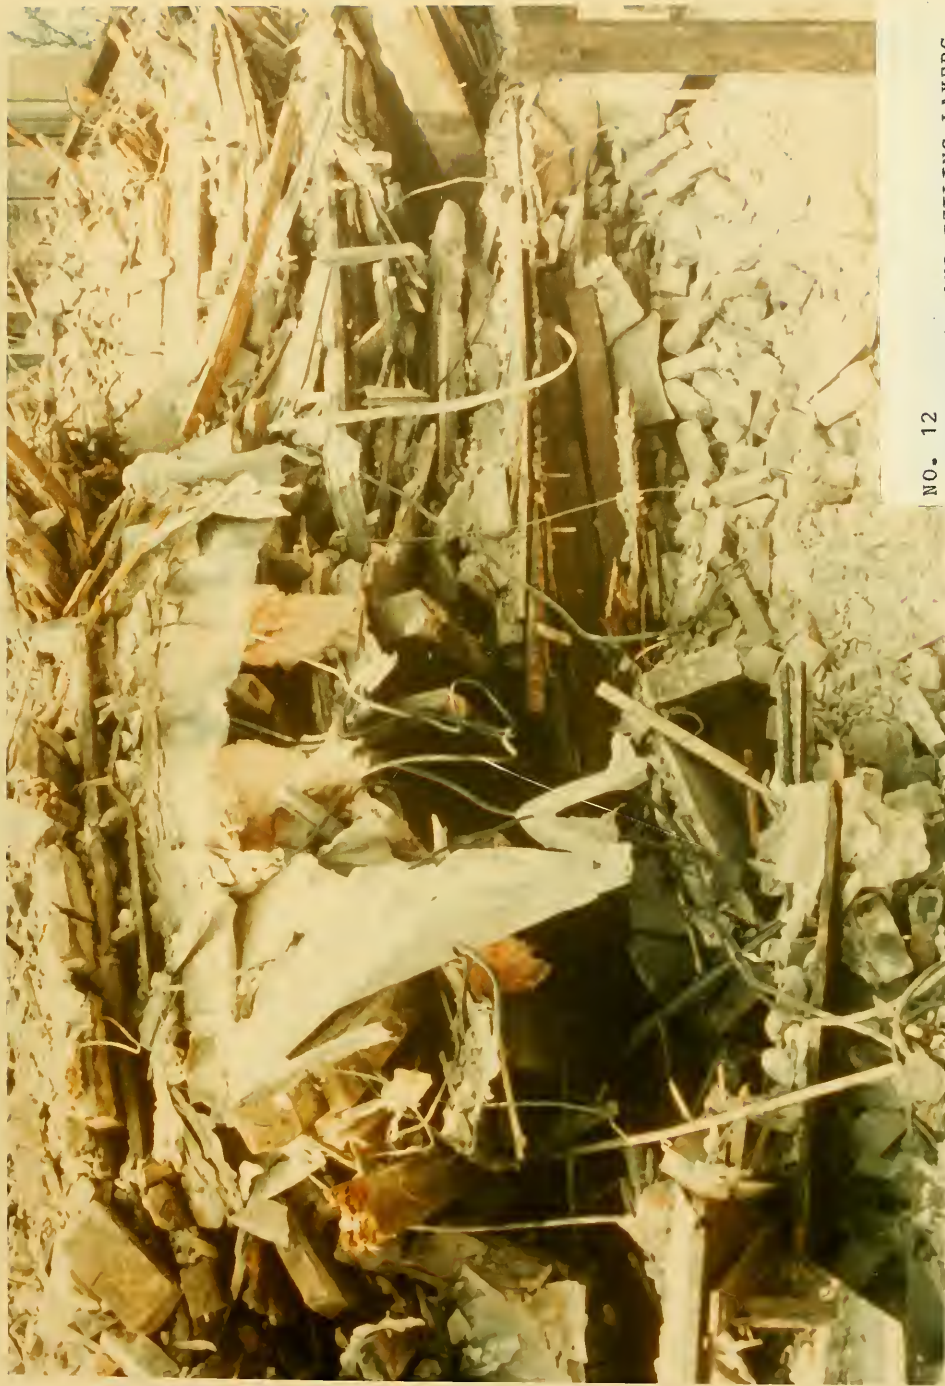
NO. 12

VIEW OF FLOOR AND CEILING LAYERS
ON SOUTH SIDE
AFTER REMOVAL OF ENGINE 15.

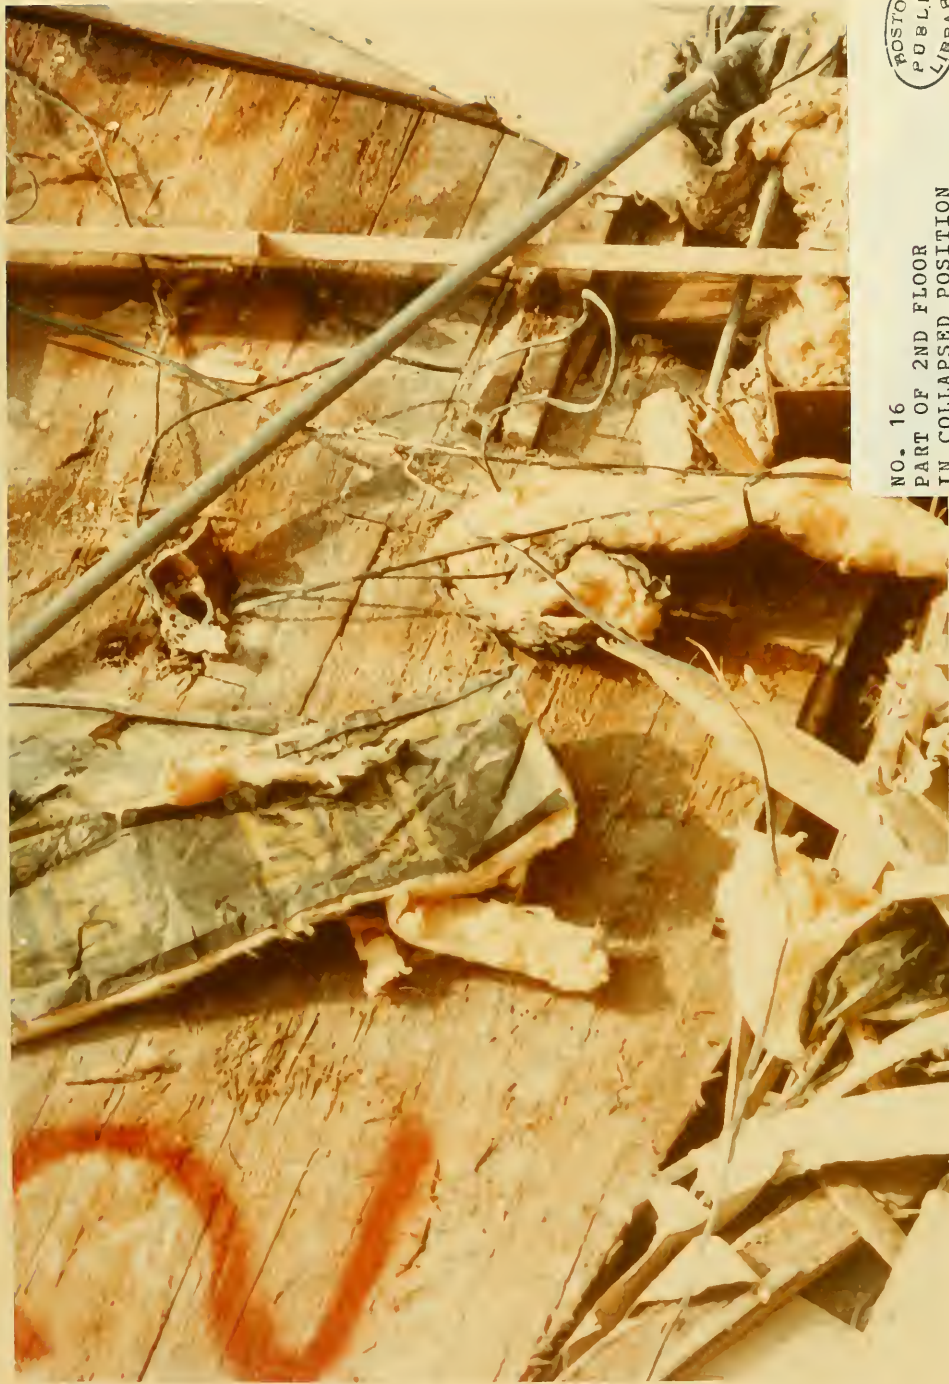
The second floor was lifted out more or less in pieces being locked in by collapsed piping and impaled on protruding steel beams. This Northerly half of the second floor was found to have a structural weakness in that some of the floor joists were not long enough to reach to the central bearing wall. The licensed builder (Mr. Joseph Lazo) stated that this weakness had been discovered during the present alteration and that temporary supports had been placed while the structural engineers analyzed this condition.

NO. 16
PART OF 2ND FLOOR
IN COLLAPSED POSITION
AND IMPALED ON STEEL BEAMS.

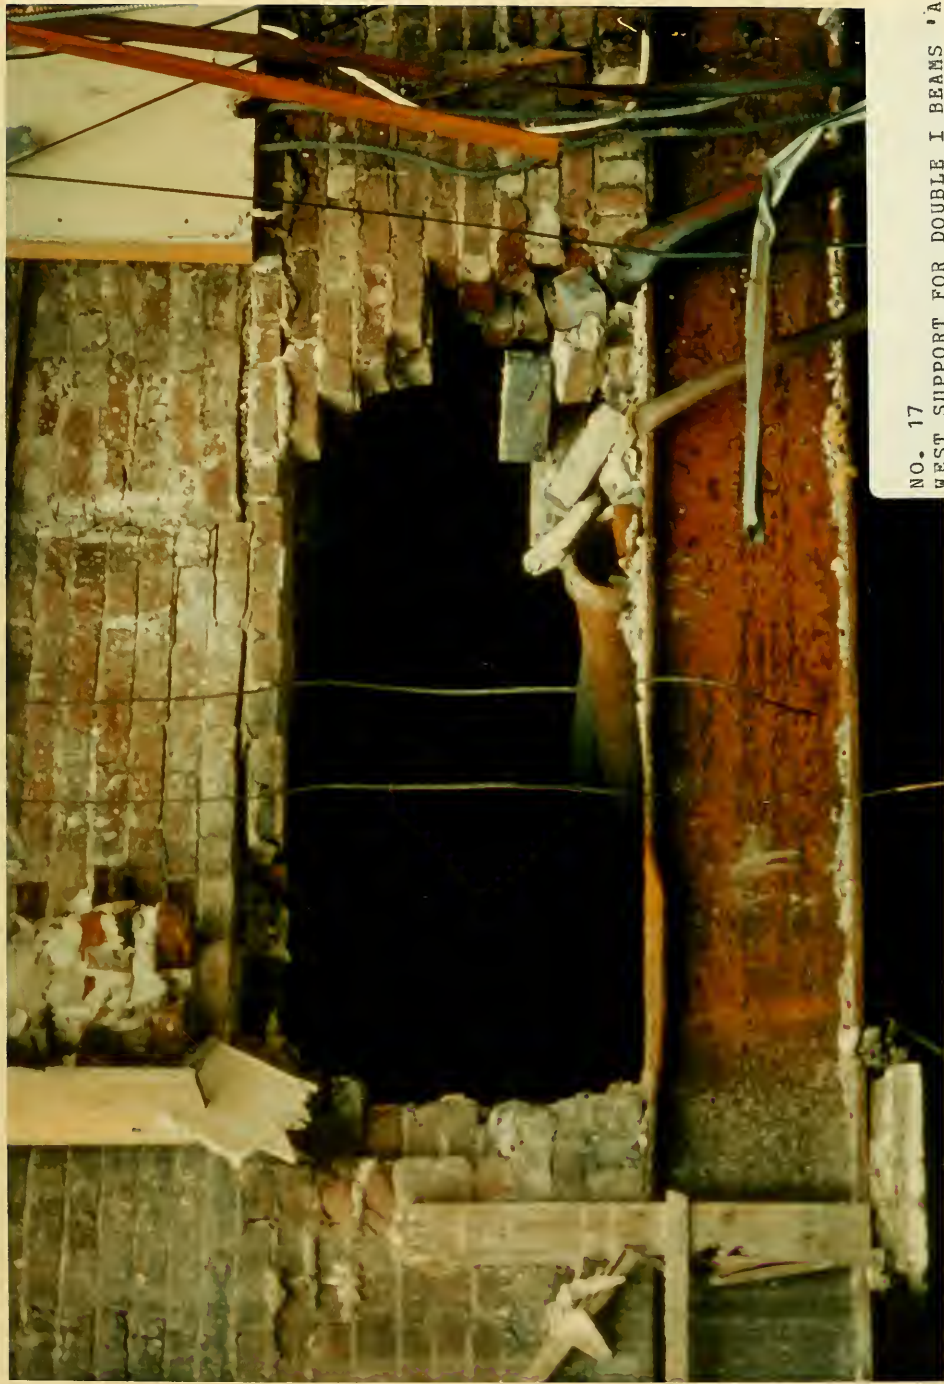
NO. 17

At the West side, the double-I-beams were supported by another set of double beams running north and south. A large rotational force was also set up at this point; a flange of the supporting beam was bent and cracked and a section of brickwork was torn out of the West side bearing wall. The floors in the main part of the building tied into the opposite side of this wall and may have prevented a progression of the collapse in this direction.

WEST SUPPORT FOR DOUBLE I BEAMS 'A'-
NOTE BENT FLANGE AND SECTION
TORN OUT OF WEST WALL

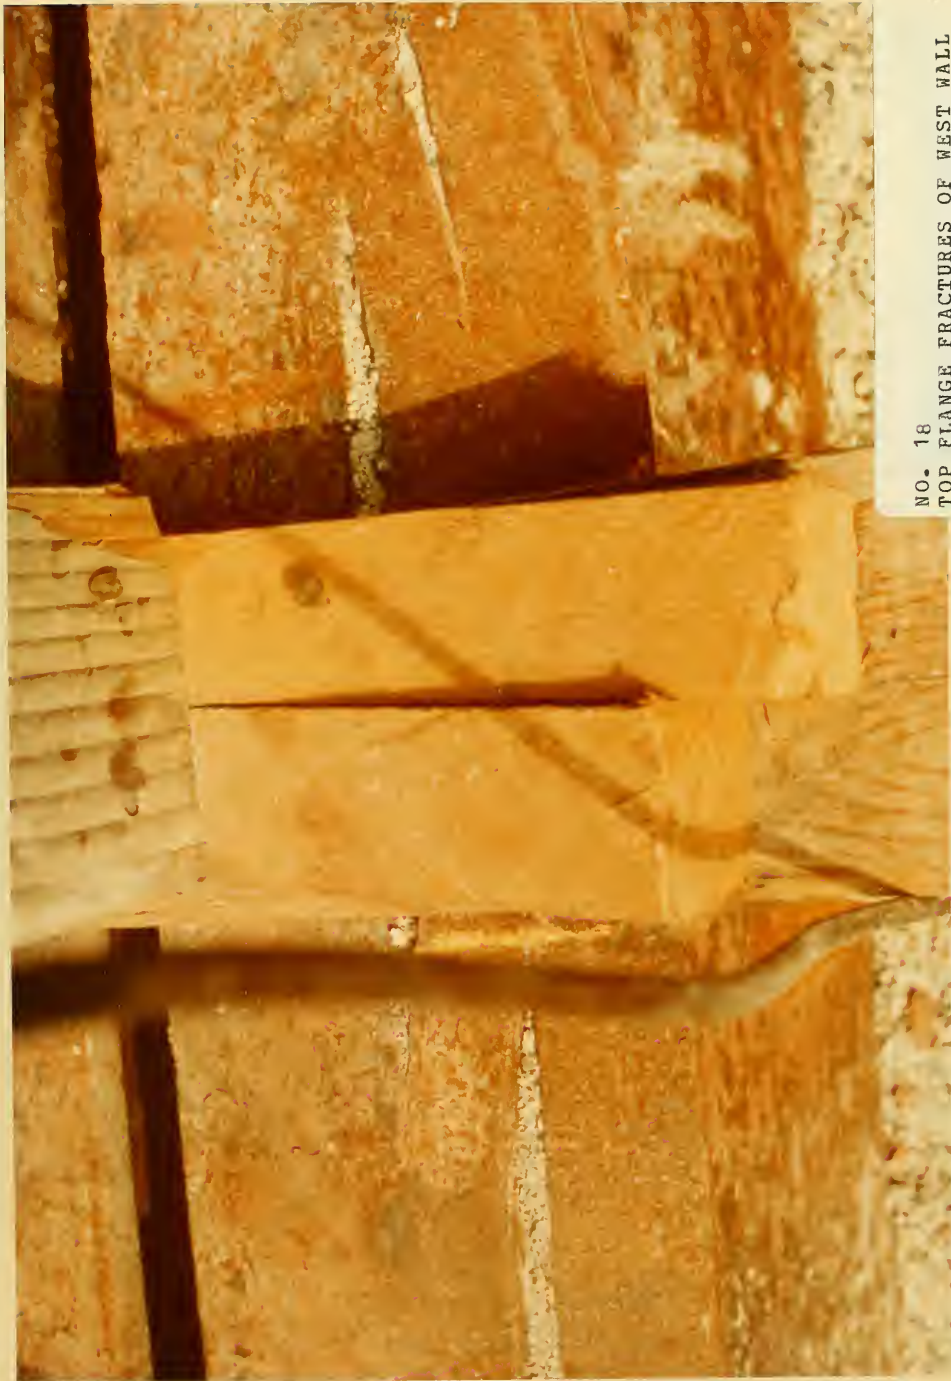
NO. 18

TOP FLANGE FRACTURES OF WEST WALL
BEAM 'F' AT SUPPORT POINT
OF DOUBLE I BEAM 'A'

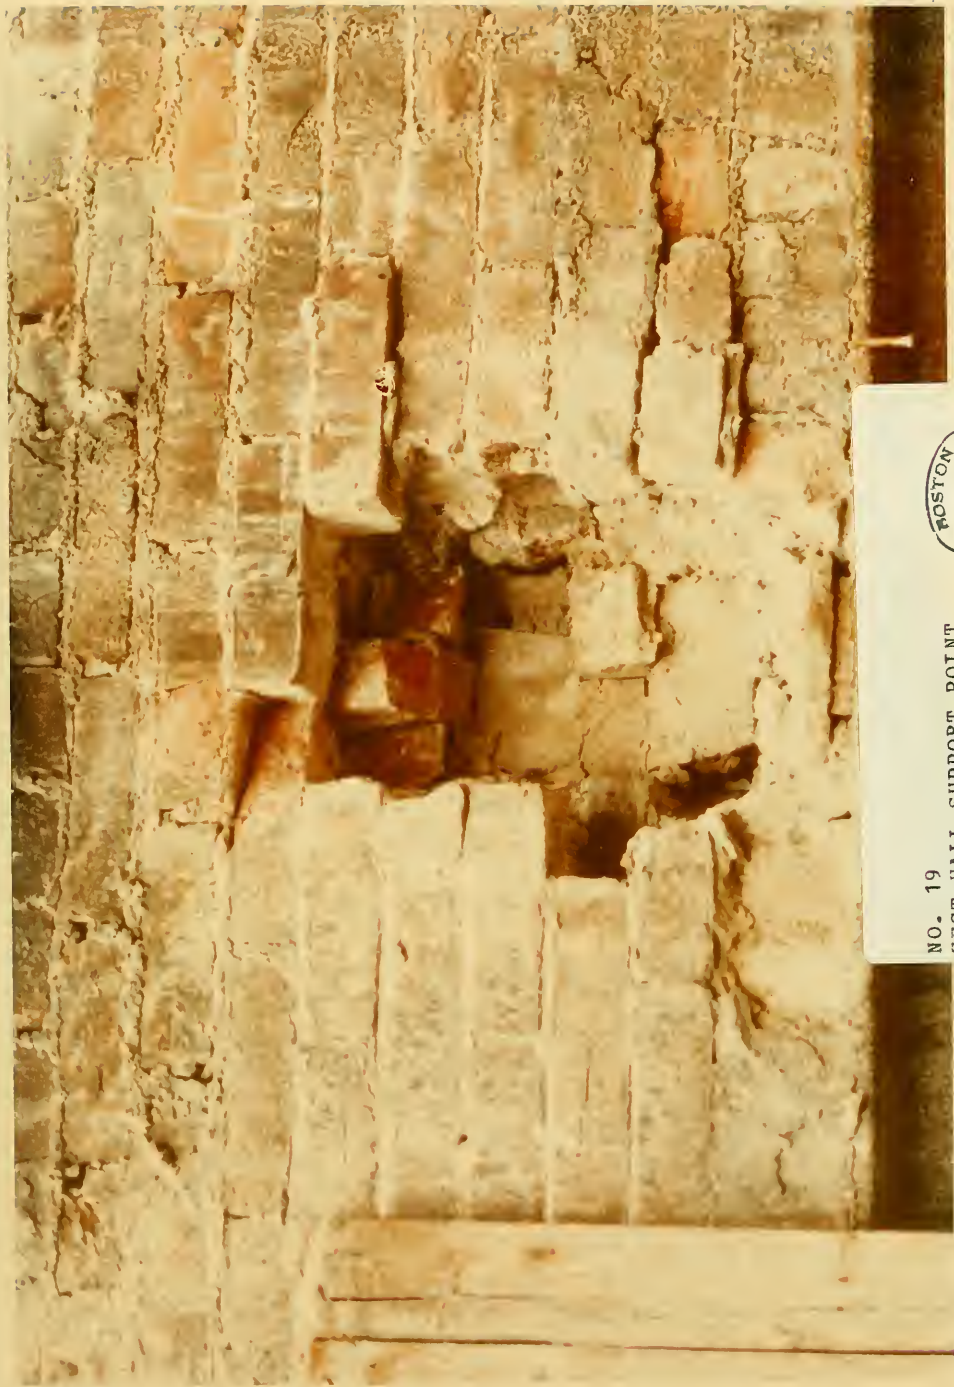
NO. 19
WEST WALL SUPPORT POINT
FOR SINGLE I BEAM 'D'

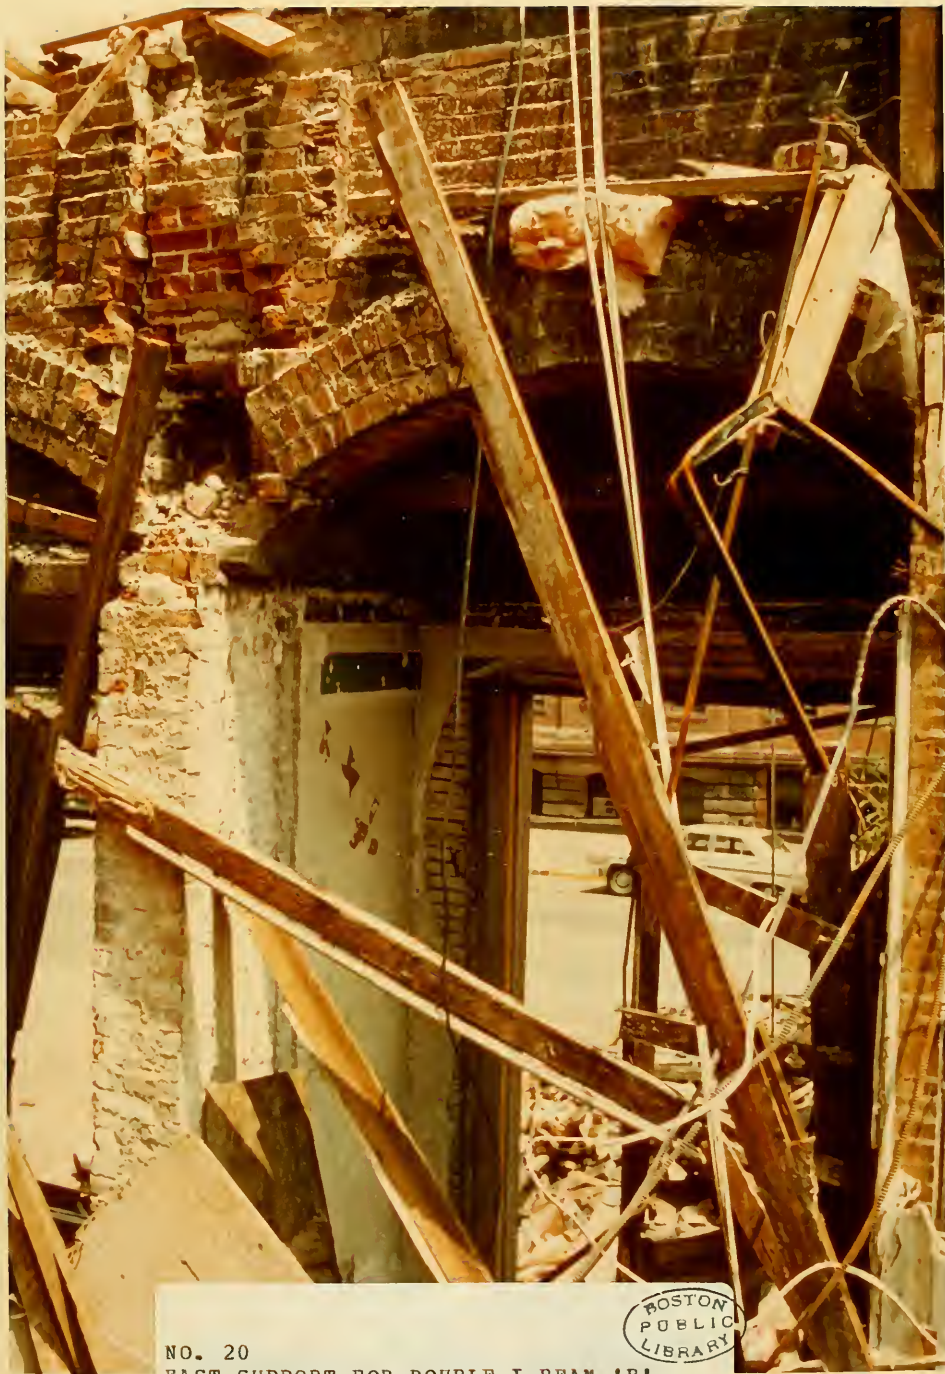
NO. 20

EAST SUPPORT FOR DOUBLE I BEAM 'B'-
NOTE BRICKS TORN OUT BY BEAM ROTATION.

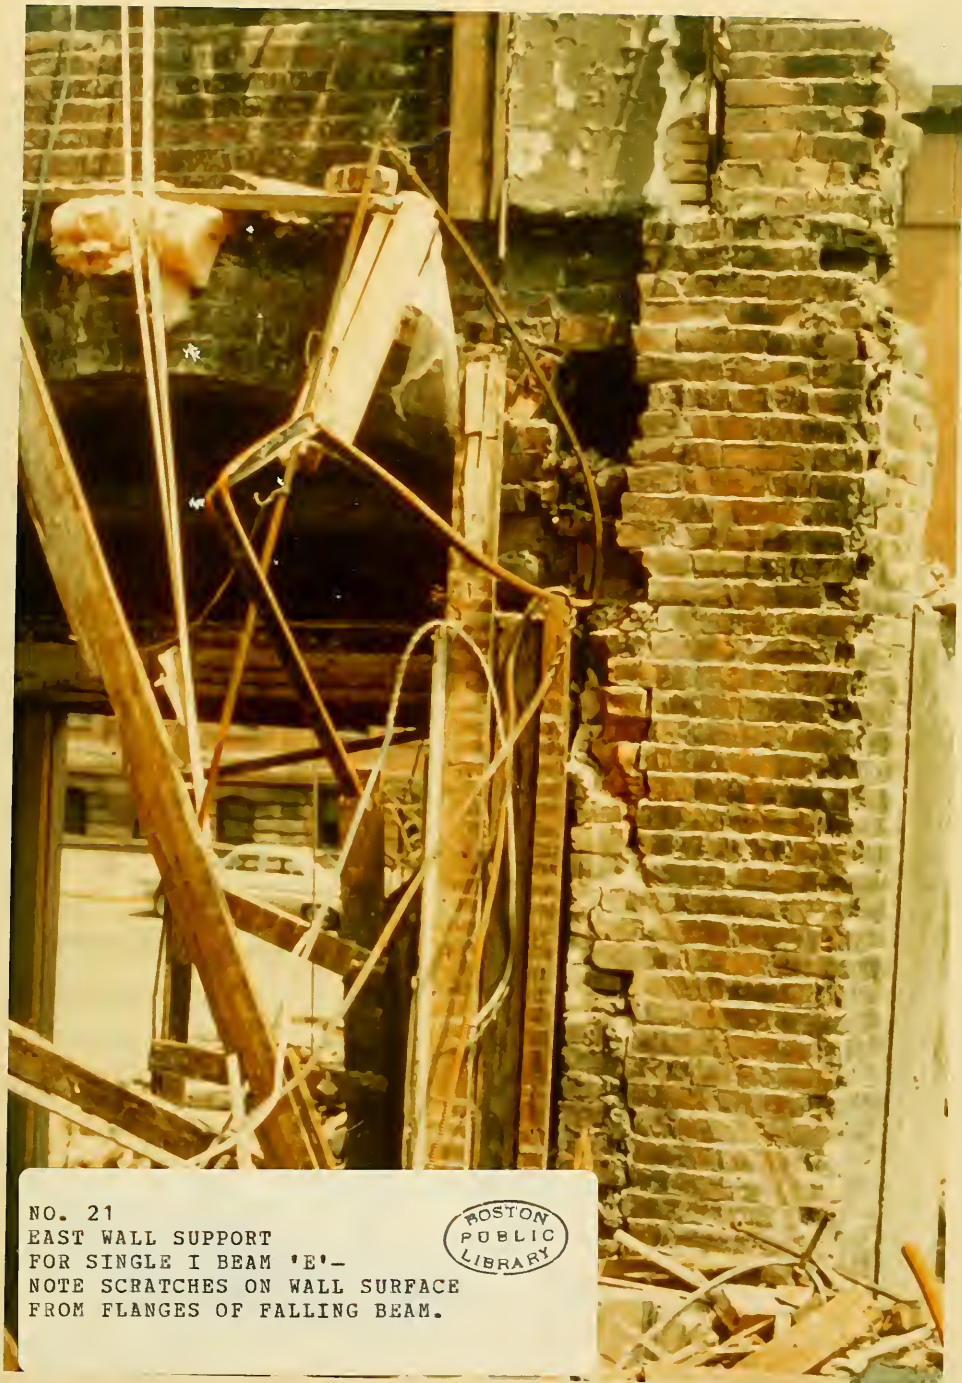
NO. 21
EAST WALL SUPPORT
FOR SINGLE I BEAM 'E'-
NOTE SCRATCHES ON WALL SURFACE
FROM FLANGES OF FALLING BEAM.

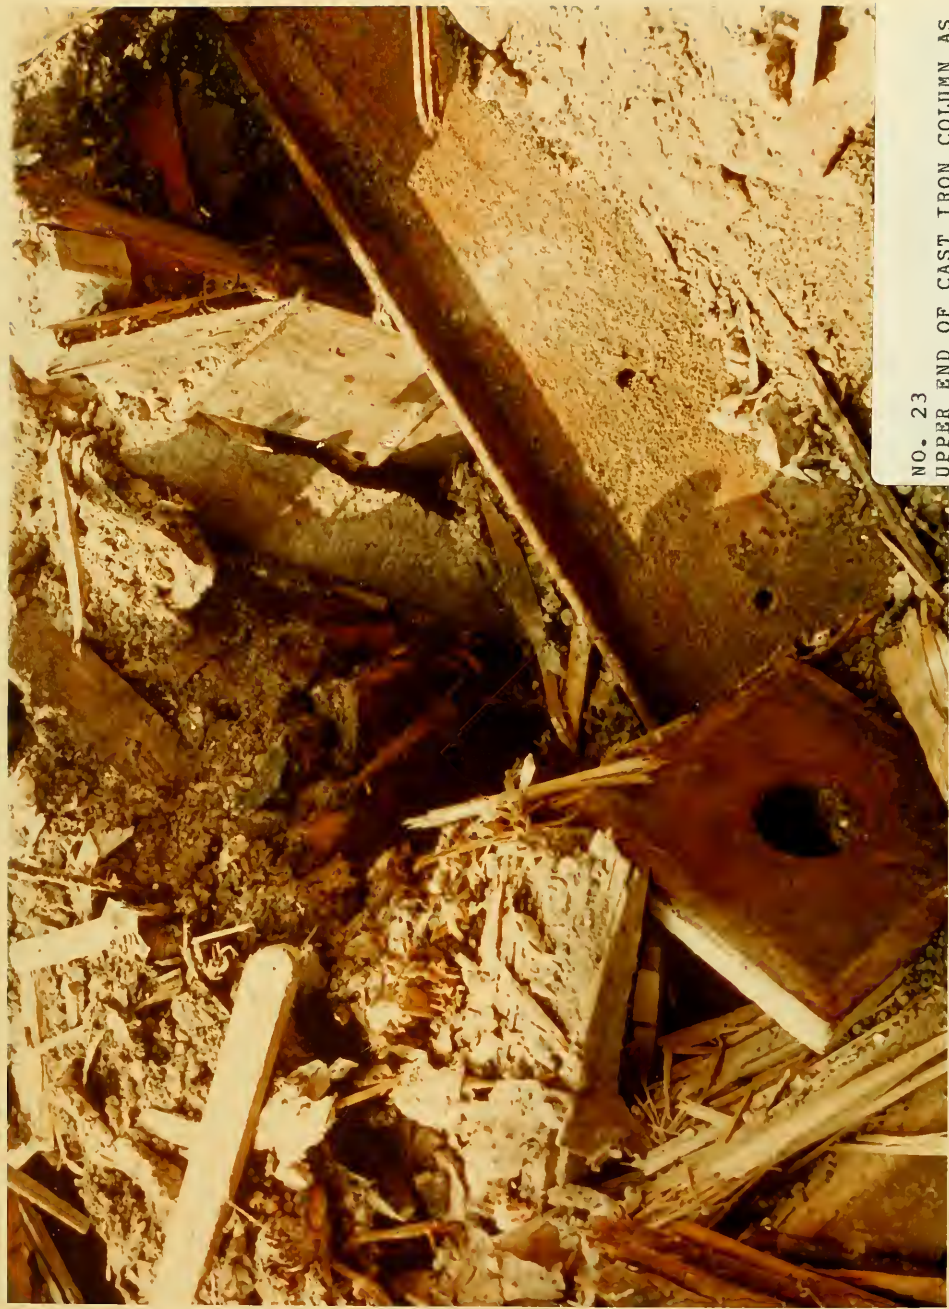
NO. 23

UPPER END OF CAST IRON COLUMN AS FOUND-
WEST SIDE DOUBLE I BEAM 'A' AT RIGHT-
NOTE GRANITE BEARING BLOCK
RESTING ON END IN DOOR OPENING.

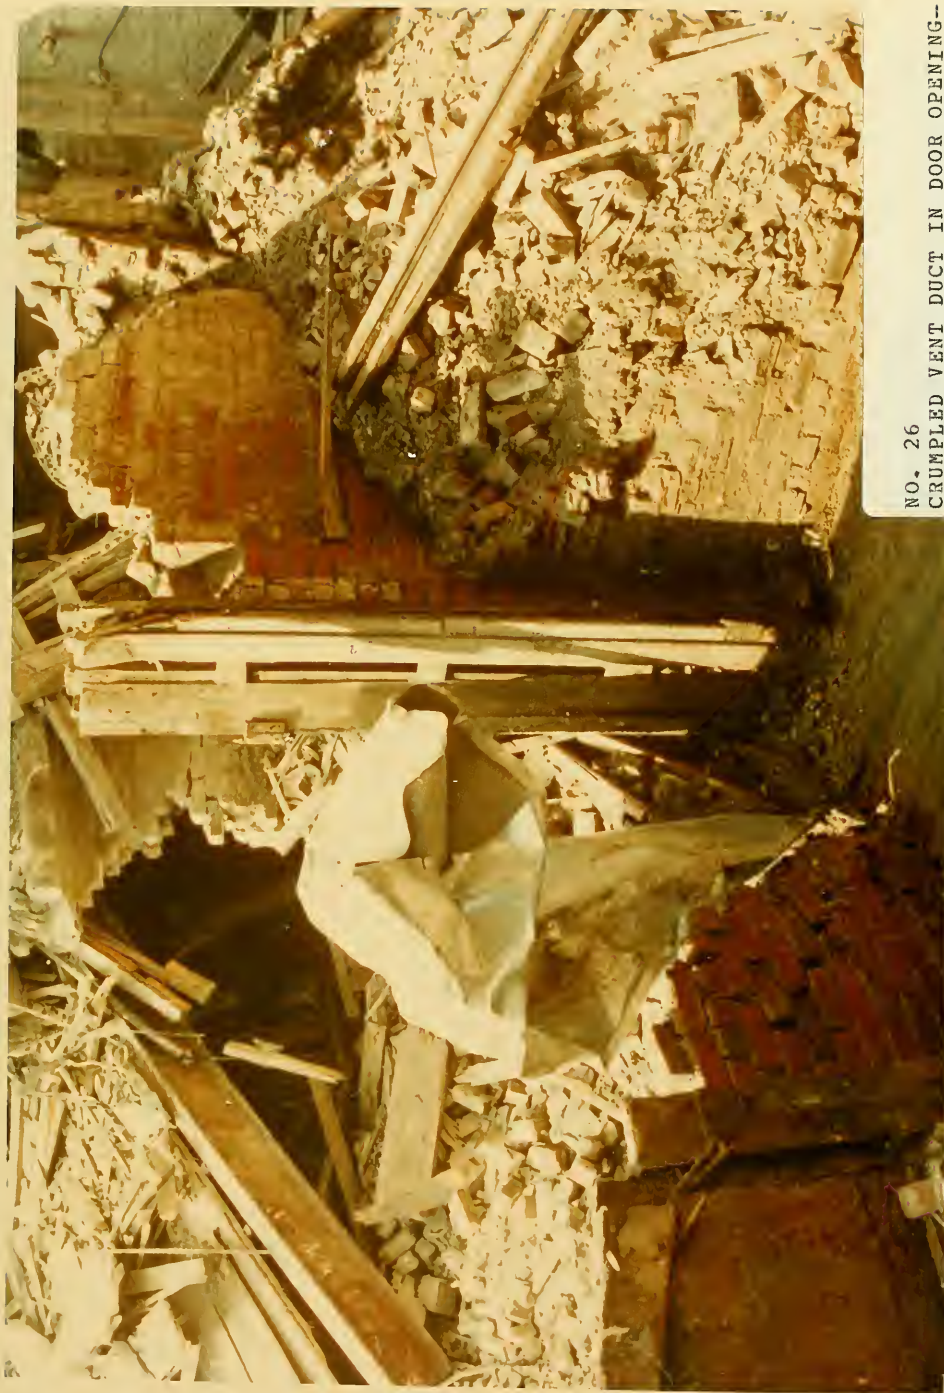
NO. 26

CRUMPLED VENT DUCT IN DOOR OPENING--
ALL DEBRIS CLEARED AWAY NORTH OF WALL--
NOTE DENT IN DUCT WHERE COLUMN RESTED.

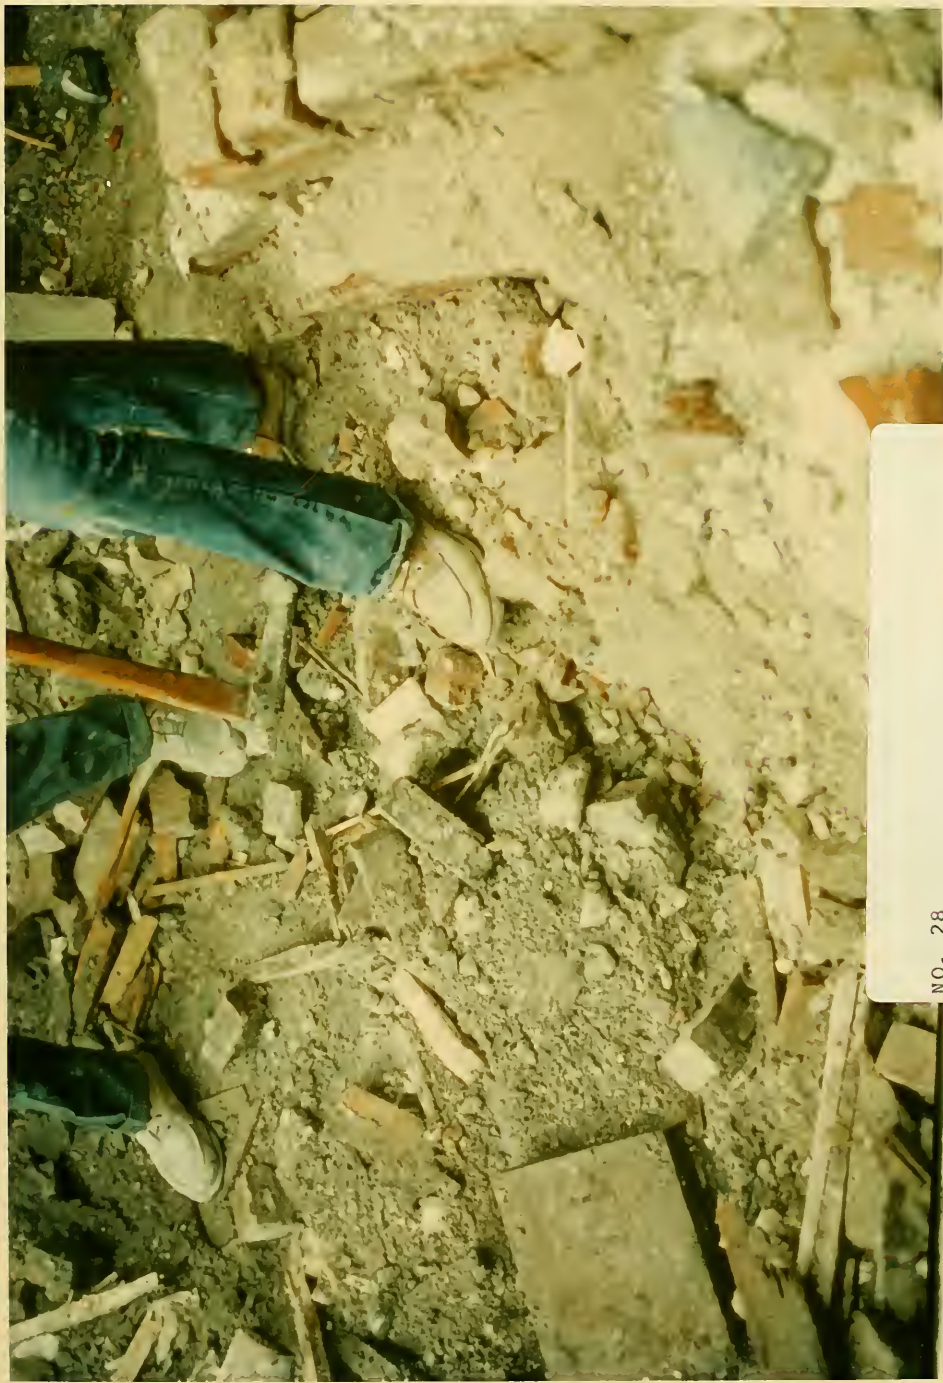
NO. 28

2:45 P.M. The column base plate (12" x 12" x 2") was found resting on the basement floor at a point 4'-6" due south of its original position. There was no debris under the plate; there were no lugs, socket, or bolts to hold the plate and column together.

COLUMN BASE PLATE AS FOUND
RESTING ON BASEMENT FLOOR

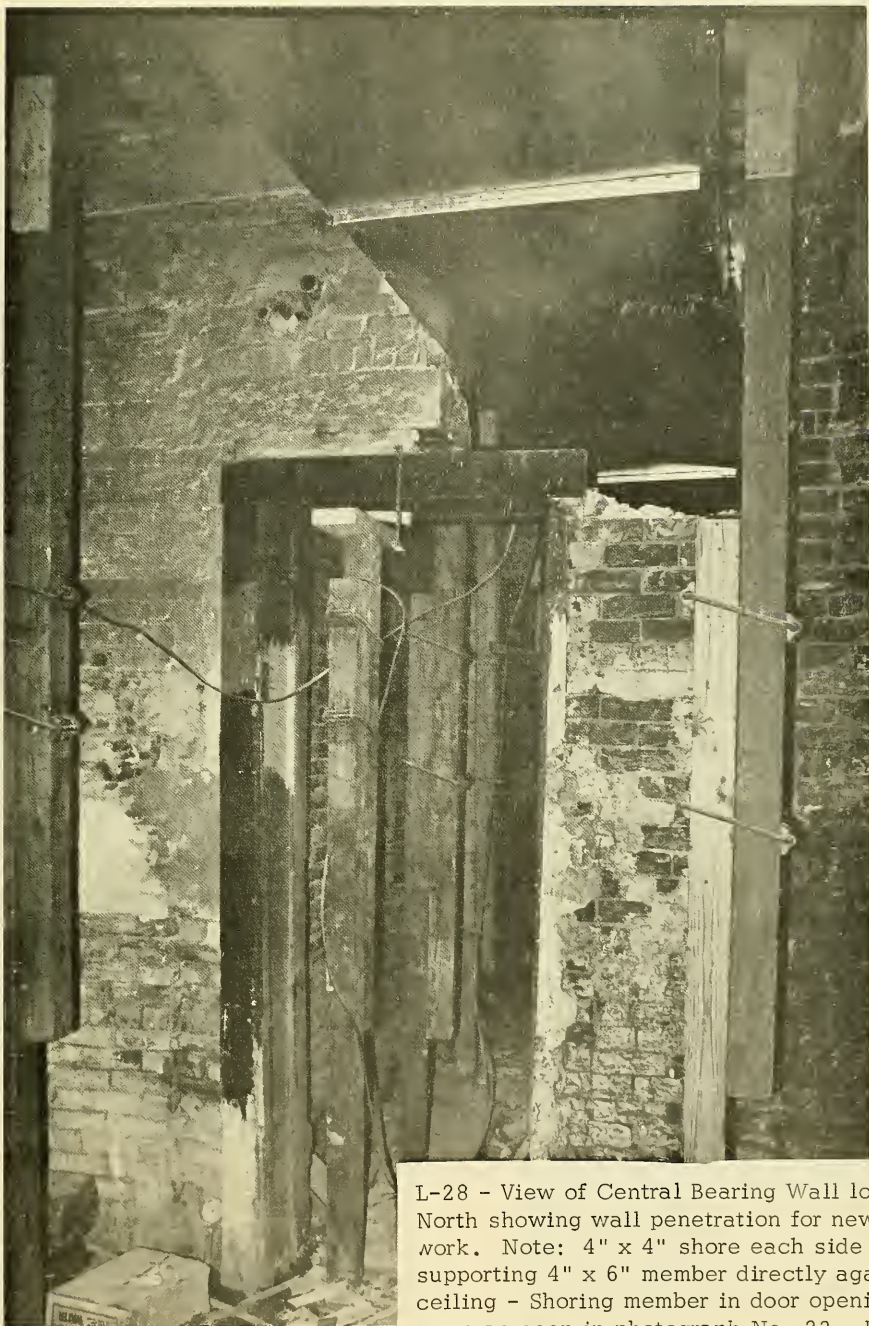
L-28 - View of Central Bearing Wall looking North showing wall penetration for new duct-work. Note: 4" x 4" shore each side of duct, supporting 4" x 6" member directly against ceiling - Shoring member in door opening is same as seen in photograph No. 23. Photograph taken by LeMessurier Associates in 1971.
